## Case Study: Forensic Analysis of a Corroded Wireline Data Logging Cable Sample with a Brass Rope Socket Cone

### Line Break Resulting in Dropped Tool

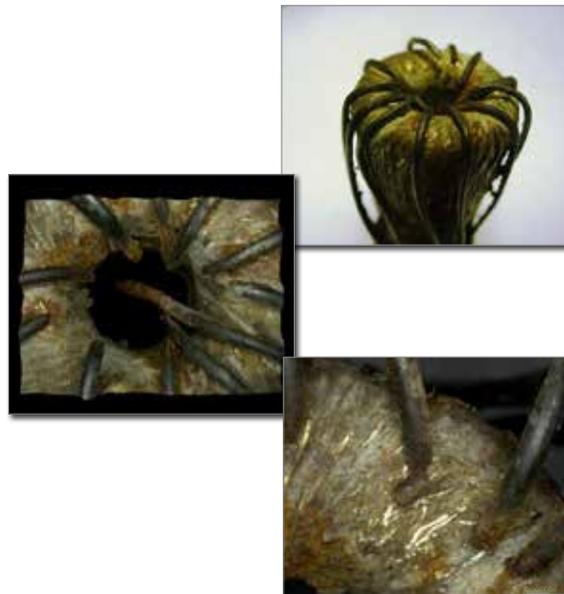
The last photo (below) is the bent area that has been straightened to reveal bare steel where the zinc has sacrificed itself in contact with the rope socket cone. Brass transfer is also apparent at the bent wire contact area.

*Brass transfer is apparent due to galvanic corrosion.*

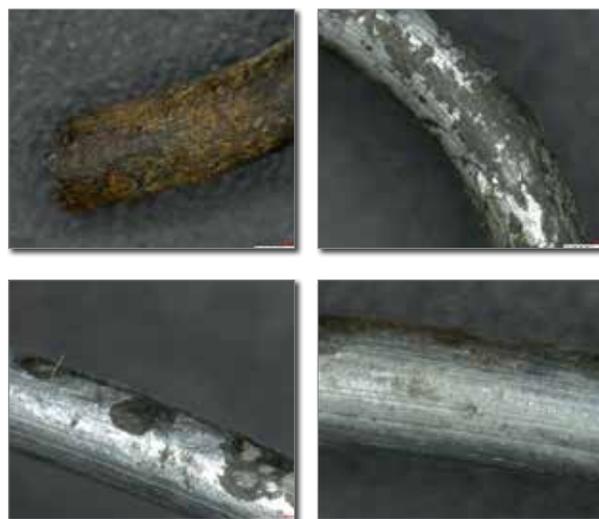
*Initial observations of rust and loss of zinc layer around the point of contact with the brass rope socket cone raise concerns, since brass and zinc are on the opposite side of the galvanic table.*

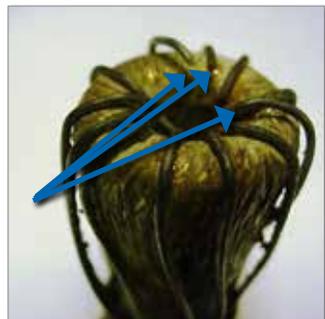
As previously noted, all wire failures were found at the entrance to, or immediately adjacent to the entrance bell of the brass rope socket cone. All twelve wires in the rope socket cone were parted in this immediate area. All twelve wires were

Parted outer armor wires found at the entrance bell of the brass rope socket cone.

As these wire failures are isolated to a very short length immediately adjacent to the bend through the bell of the brass rope socket cone, it is recommend to review the procedure for cable re-heading with focus on how to modify the procedure or what might be added to the procedure to provide additional protection against corrosive/galvanic attack in the immediate area of the bell of the brass rope socket cone.

- Limiting exposure time to hydrochloric acid.
- Pack rope socket with nonconductive grease.
- If exposure to hydrochloric acid is expected, rinse rope socket with fresh water after exposure and re-head as often as possible.
- Alert oil & gas operation supervisors to the hazards associated with exposing wireline cables to high concentrations of acid prior to staging and perforating in acid operations.
- Alloy metals that are resistant to Hydrogen Sulfide are not necessarily resistant to Hydrochloric acid and may not protect from wire embrittlement.

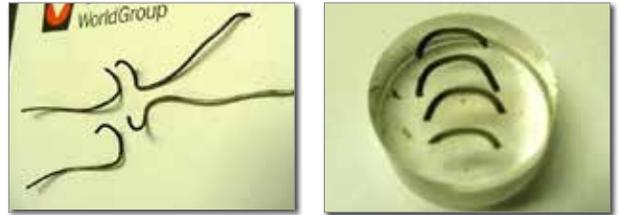
Preparation of samples for metallographic examination

Due to the appearance of red rust on all four samples, it was chosen not to use the zinc stripping solution. When these samples were final polished and introduced to the etching solution, all etched properly. This indicates that there was no residual zinc and that both the zinc and iron/zinc alloy layer had been sacrificed to some corrosive or galvanic environment.
