Wireline Cables Forensics 101: A review of how forensics is used to determine the cause of wireline failures.

Forensic Analysis of Wireline Cables

Wireline failures are usually classified as either mechanical or electrical and each requires an experienced investigator to determine what has caused the damage to the cable. This article is the first in a series that will outline how engineers at Camesa systematically examine damaged wireline cables and shed light on the telltale clues that help them diagnose how a cable has failed. In this technical bulletin, we focus on wire breaks seen mainly in the outer steel armor wires of the cable.

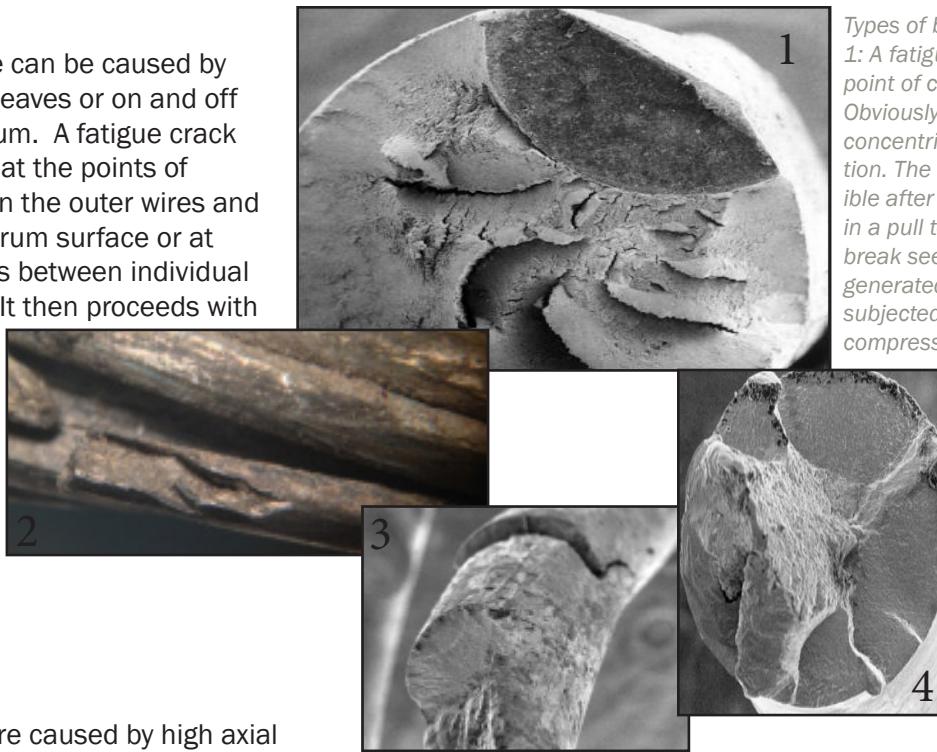
Fatigue Breaks

Types of bend fatigue break: Fig. 1: A fatigue crack starting at the point of contact with a sheave. Obviously the crack propagated concentric to its point of initiation. The crack only becomes visible after destroying the strand in a pull test; Fig. 2: The fatigue break seen here is due to a crack generated when the wire was subjected to local bending and compression. This can be due to using an improper diameter sheave or even a wireline jumping a sheave; Fig. 3: Two adjacent fracture cracks. This kind of failure can often be seen if wires are subjected to local bending and compression; Fig. 4: Wire fatigues in a rotary bending test. The cracks initiate from all around the circumference.

Bending fatigue can be caused by running over sheaves or on and off of a wireline drum. A fatigue crack normally starts at the points of contact between the outer wires and the sheave or drum surface or at crossover points between individual wireline wires. It then proceeds with increasing number of bends, finally creating a fracture which is perpendicular to the wire axis.

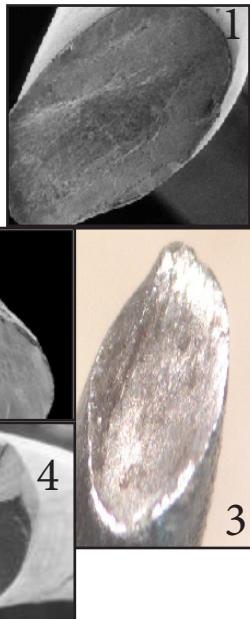
Shear Breaks

Fig. 1: A typical 45 degree shear break. Note that there is a small reduction in diameter at the edge of the fracture surface, but it is small compared with the necking associated with the ductile tensile cup and cone failure. Fig. 2: High transverse loading initially caused severe plastic wear. Finally the wire failed in shear. Fig. 3: A typical 45° shear break is seen here. This type of break is commonly seen when the wireline breaks as a consequence of jumping a sheave or being wedged in. Fig. 4: A fatigue crack has propagated to a critical level before the remainder of the wire failed in shear.

Shear breaks are caused by high axial loads combined with perpendicular compression of the wire. Their break surface is inclined at about 45 degrees to the wire axis. The wire will fail in shear at a lower axial load than a pure tensile overload.

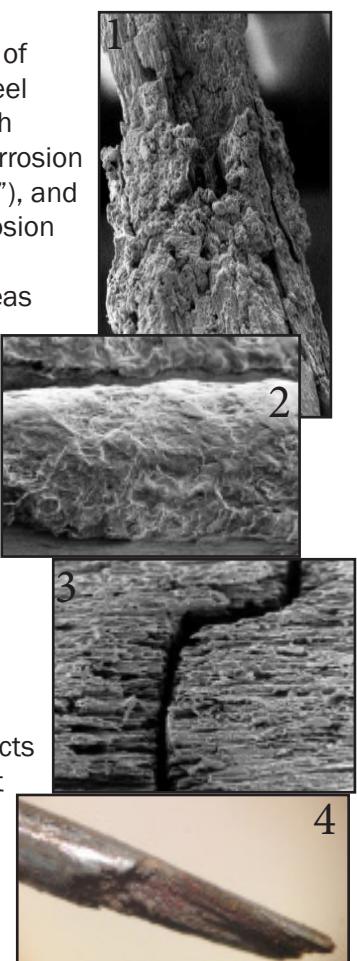
Corrosion Fatigue Break

PHOTOS ON RIGHT Fig. 1: Severe uniform corrosion (atmospheric corrosion). Static ropes and ropes operating in a marine environment should be galvanized and well lubricated. A plastic coating between the steel core and the outer strands will protect internal rope elements. Fig. 2: Surface corrosion. Please note the increase in the effective diameter of the wire. Fig. 3: Stress corrosion crack. Tensile stress help propagate a crack initiated by corrosion. Fig. 4: A corrosion fatigue break is seen here. As can be seen in the examples photos, the highly oriented striations in the steel wire become apparent in the corroded state.

Corrosion is the reaction of metal with oxygen. In steel wire ropes, we distinguish between atmospheric corrosion (producing uniform "rust"), and more local forms of corrosion such as pitting corrosion (creating deep pits in areas where the protective coating is damaged or missing). Corroded steel wire rope will lose its strength and flexibility. Corroded wire surfaces will form fatigue cracks much faster than protected surfaces.

The galvanizing on Camesa's wireline products helps reduce the amount of corrosion on their wirelines by reducing the exposed steel surface with zinc coating. The plastic insulation on the copper conductor also serves as a corrosive barrier for the copper conductor.

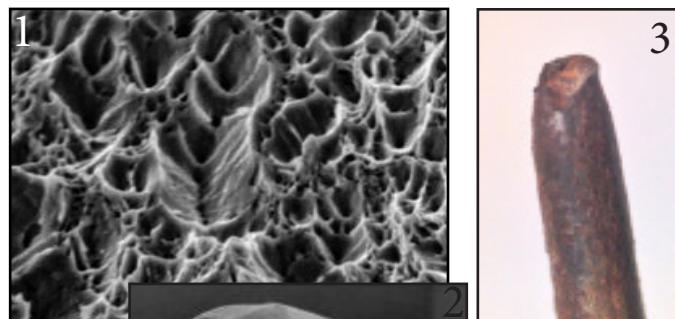
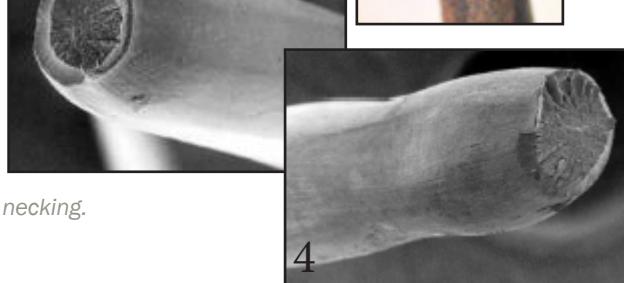
Tensile Overload Break

Fig. 1: Ductile dimple formations in the steel microstructure are clear indication of a tensile overload (enlarged view of the break surface of a cone center). Fig. 2: A classic cup and cone fail. The diameter reduction at the fracture is clearly visible. Fig. 3: A classic cup and cone failure (possibly at a crossover point) due to tensile overload. The diameter reduction at the fracture is clearly visible. This type of break is also seen in combination with other type of wire breaks. Fig. 4: Before failing by tensile overload, this wire developed two areas of local necking.

Tensile overload breaks are created when the axial load in the individual wire exceeds the wire's breaking strength. Tensile overload breaks are generally associated with a ductile wire diameter reduction at the point of break and the formation of the typical "cup and cone" ends.

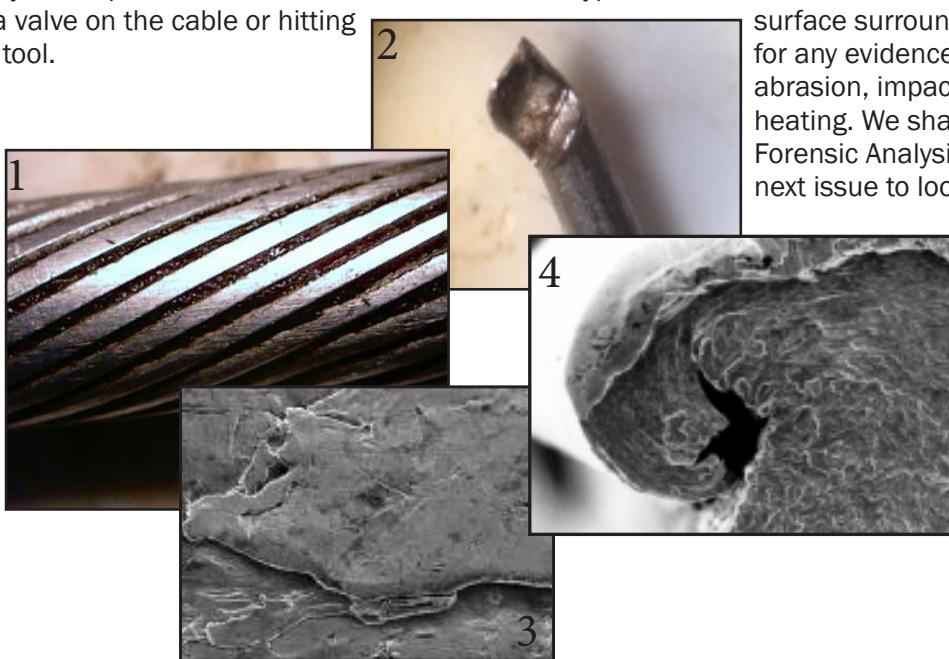
Mechanical Wear and Damage

Fig. 1: Mechanical wear of the outer wires can be seen. Fig. 2: The wire break seen in this picture has broken due to an impact with a tool or harder object. Some plastic deformation is visible. Fig. 3: Wear surface of an outer wire of a steelwire rope. Fig. 4: Plastic wear on the surface of an outer wire. The material displacement is very visible.

Mechanical wear in steel cables is the removal of material due to mechanical abrasion. Due to wear against sheaves, drums or neighboring cable wraps, a wireline diameter will initially reduce at a high rate. With increasing wear, however, the bearing surface of the wireline will increase and the cable diameter reduction will slow correspondingly. Mechanical damage can also be caused by the impact of a hard surface such as closing a valve on the cable or hitting it with a tool.
